Tanyard Springs HOA - CSG - Concrete Spalling RFP

**RE: Tanyard Springs HOA, Glen Burnie, Maryland
Sidewalk Limited Condition Evaluation
CSG Project # 20-133**

Ms. Shireen Ambush
Tanyard Springs HOA
Sidewalk Limited Condition Evaluation
May 12, 2021
Page 4 of 12

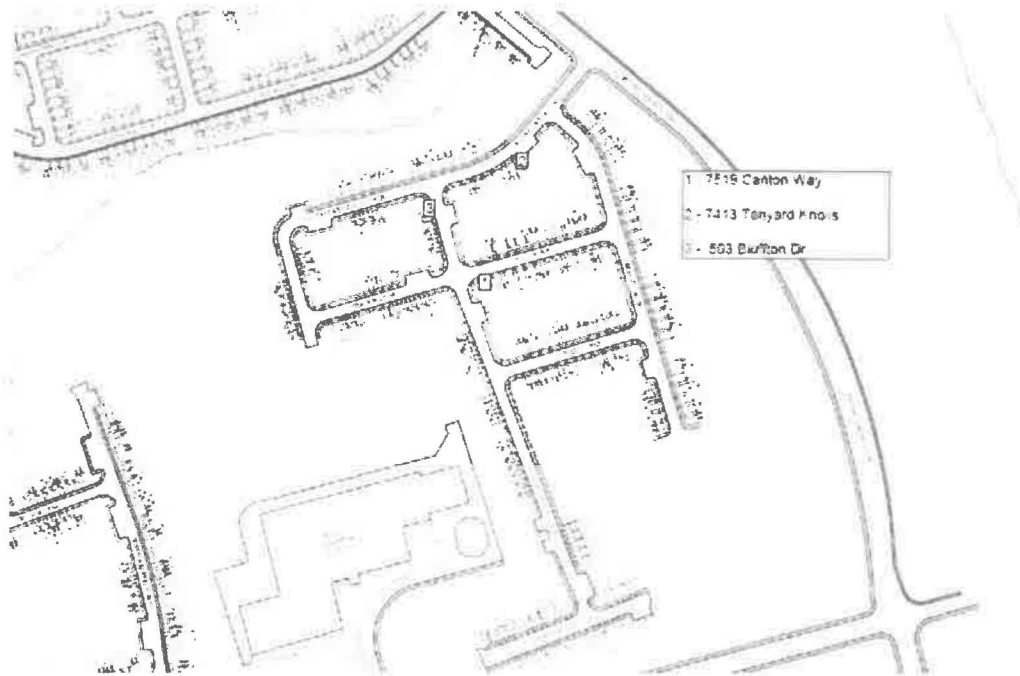
Elementary School (Photo 1). The concrete surfaces in this area display deterioration in the form of concrete scaling and exposed aggregate.

Photo 1 – Property cluster west of the Solley Elementary School.

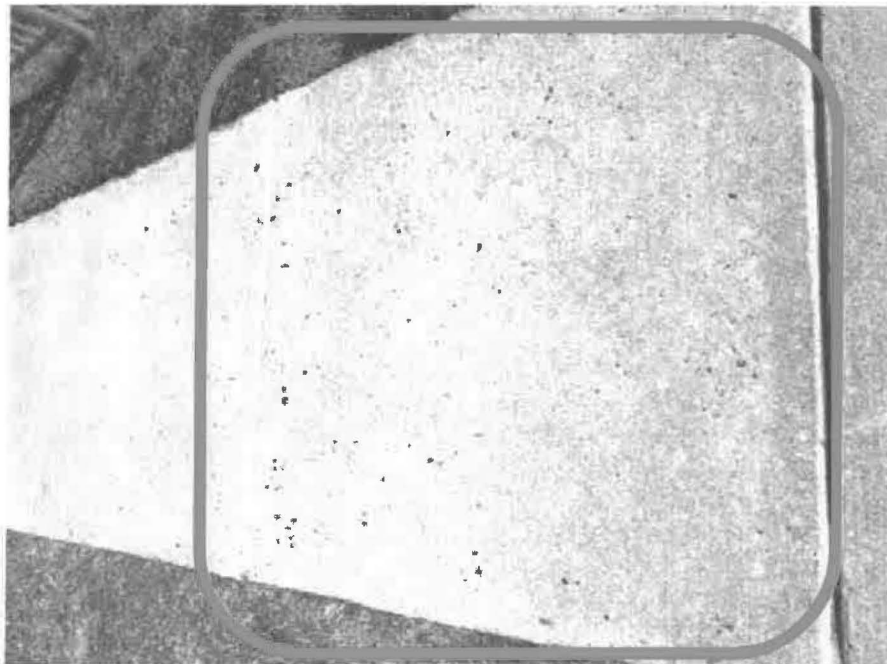
Light deterioration of the sidewalks was characterized by the loss of surface substrate without the exposure of the coarse aggregate (Photo 2). Medium deterioration of the sidewalks was characterized by the loss of surface substrate and exposure of the coarse aggregate (Photo 3). Severe deterioration was characterized by the loss of the surface substrate with some loss of the substrate surrounding the aggregate particles (Photo 4).

Photo 2 – Typical view of Light Deterioration.

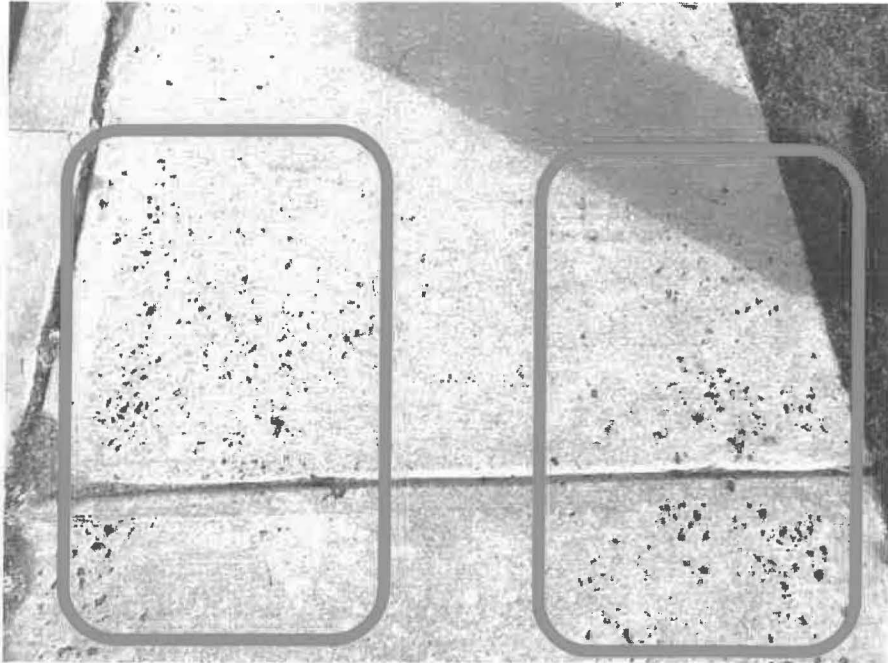
Photo 3 – Typical view of Medium Deterioration.

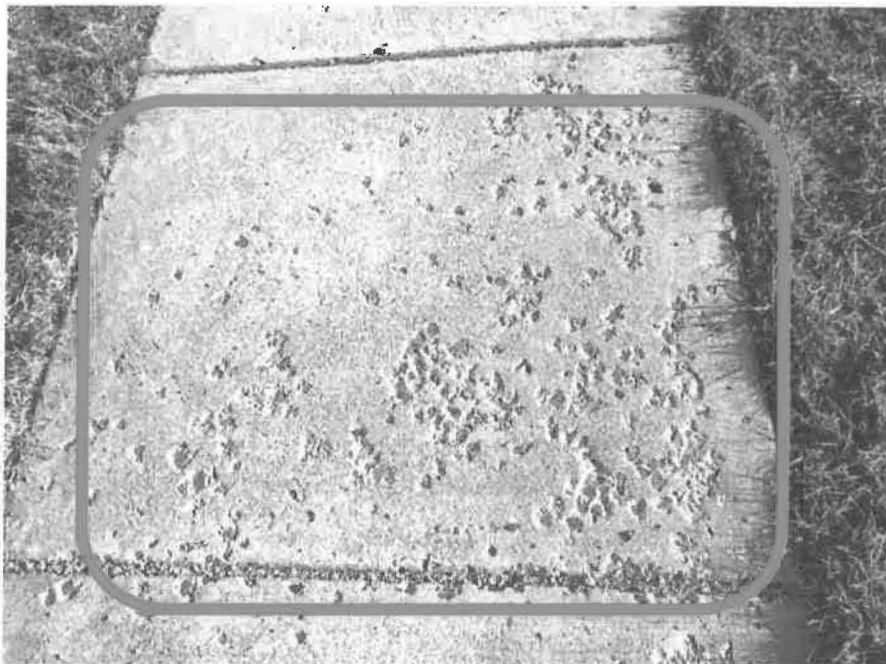
Photo 4 – Typical view of Severe Deterioration.

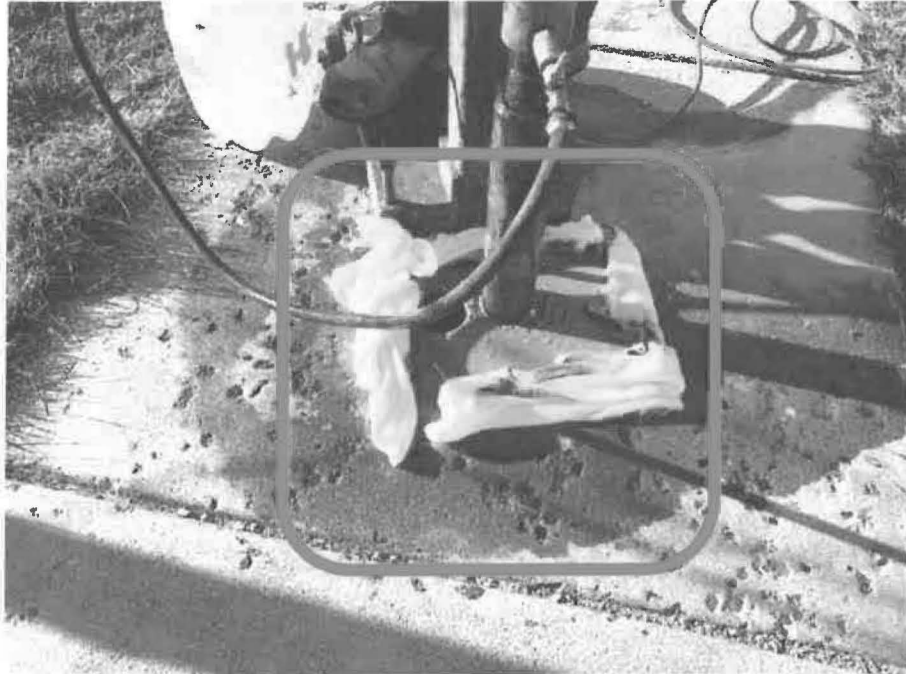
On March 11, 2021, CSG supervised F&R technicians collect a total of six (6) concrete core samples at three (3) locations, generally representative of the varying degrees of deterioration observed at property cluster (Photo 5). Sampling locations were patched following the extraction of the samples (Photo 6), which were labeled as follows:

Photo 5 – Typical view of concrete core sample collection.

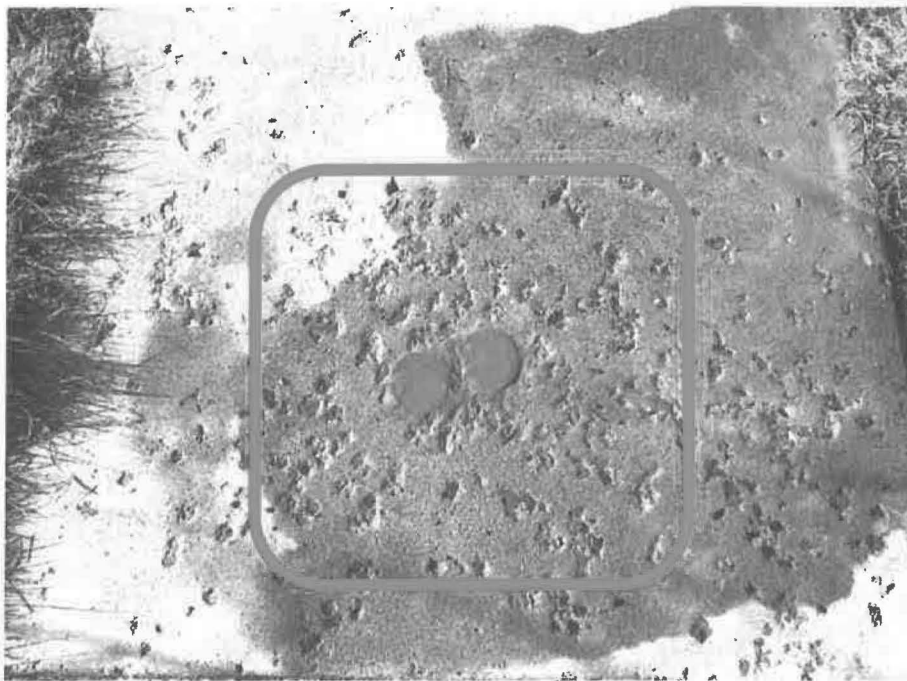
Photo 6 – Typical view of sampling area patched upon completion of collection.

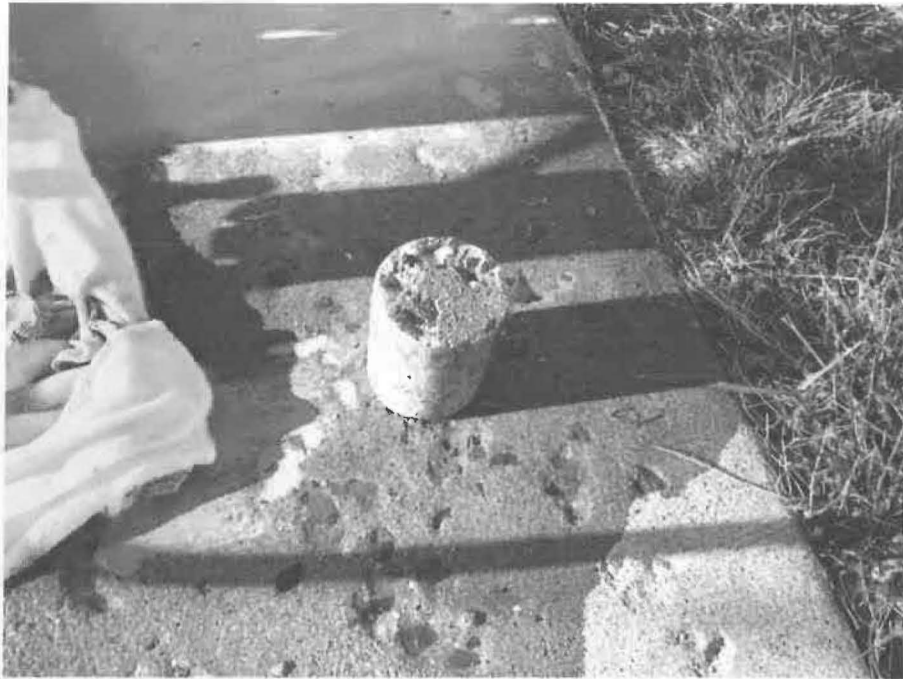
The sample average dimensions were 3.25-in long by 2.64-in diameter. Surface deterioration in the form of scaling and erosion was typical for the collected samples (Photos 6 and 7). Petrographic analysis was performed on samples 1A, 2A, and 3A according to ASTM C856-20 – Standard Practice for Petrographic Examination of Hardened Concrete. The following is a summary of the petrographic analysis results:

Photo 7 – Typical view of scaling in collected sample.

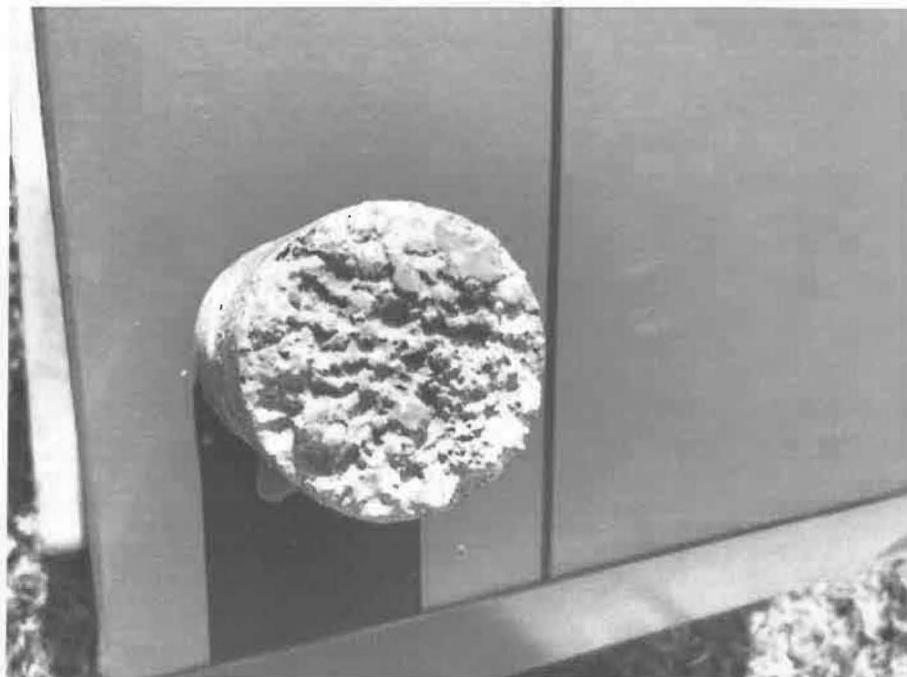
Photo 8 – Typical view of erosion in collected sample.
