RESERVE STUDY

Tanyard Springs Homeowners Association

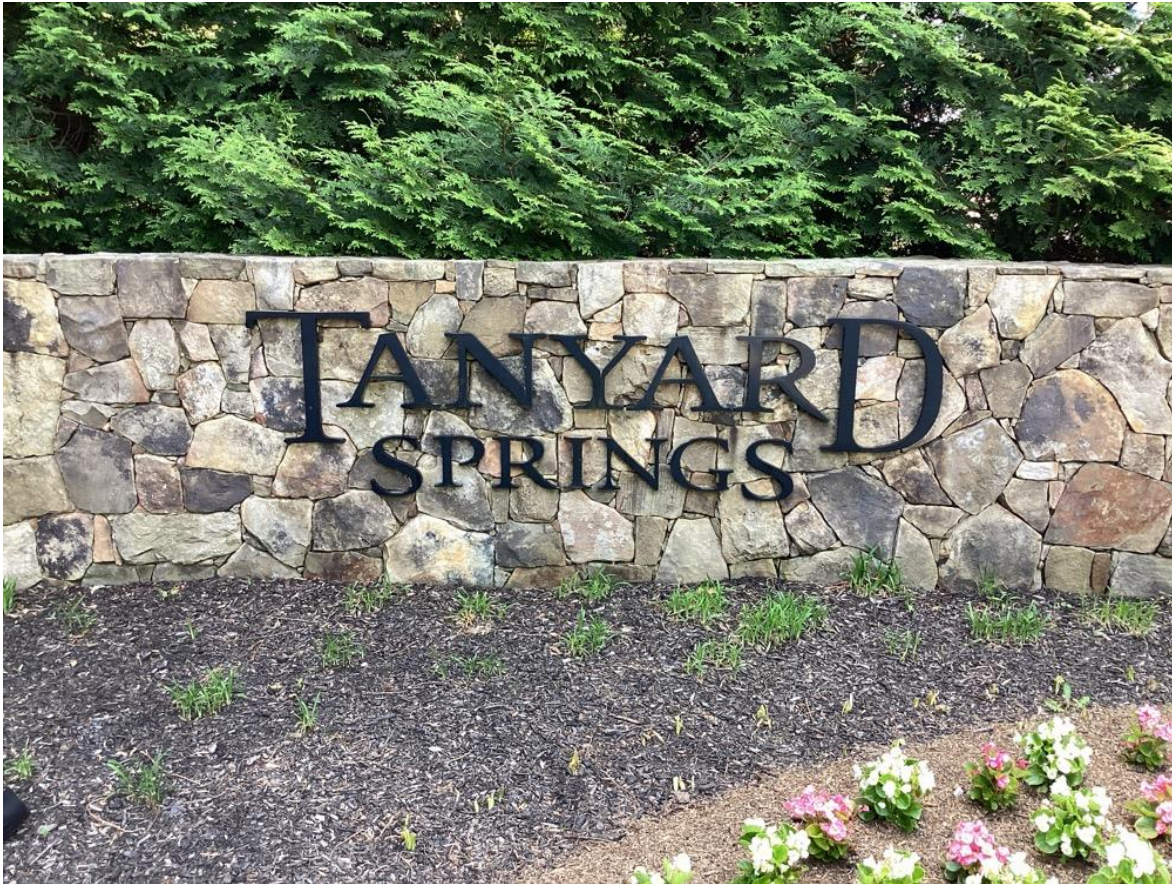
Glen Burnie, Maryland

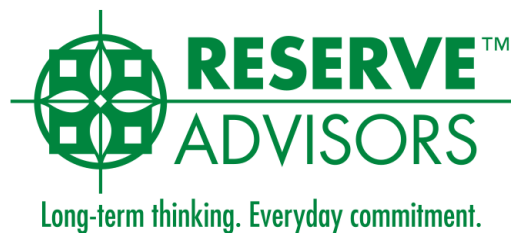
This Report contains intellectual property developed by Reserve Advisors, LLC and cannot be reproduced or distributed to those who conduct reserve studies without their written consent.

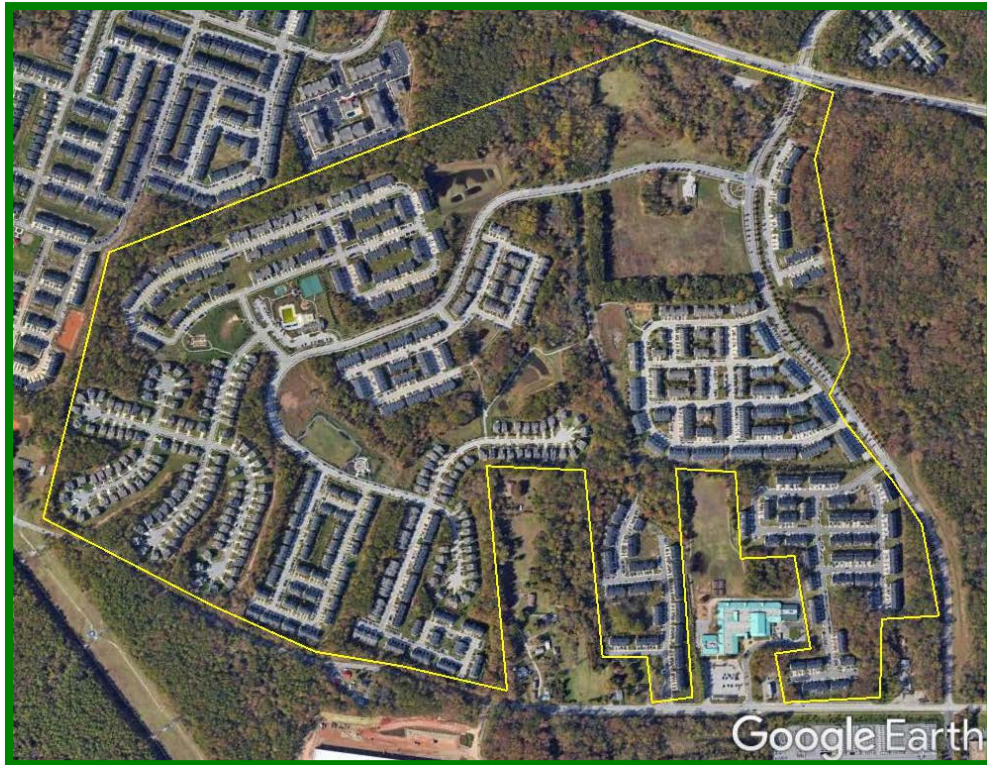
Our investigation includes Reserve Components or property elements as set forth in your Declaration. The Expenditure tables in Section 3 list the elements contained in this study. Our analysis begins by segregating the property elements into several areas of responsibility for repair and replacement.

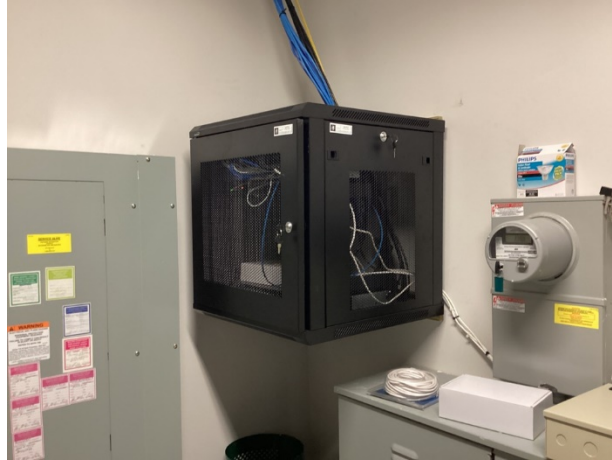
- General Maintenance to the Common Elements
- Expenditures less than \$8,000 (These relatively minor expenditures have a limited effect on the recommended Reserve Contributions.)
- Basketball Court, Archibald Drive, Mat
- Catch Basins, Landscape
- Clubhouse Parking Area, Crack Repairs, Patching and Striping
- Clubhouse Trash Corral
- Community Garden, Pea Gravel, Replenishment
- Community Garden, Plastic Shed
- Computers and IT Equipment

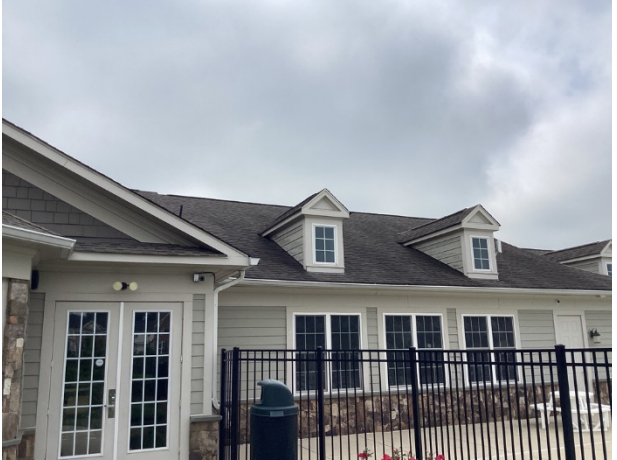
Clubhouse roof overview
Note: Stains.

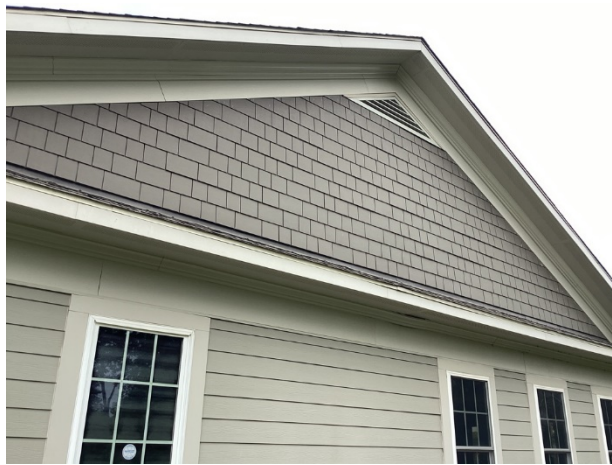
Fiber cement walls, trim, soffits and fascia

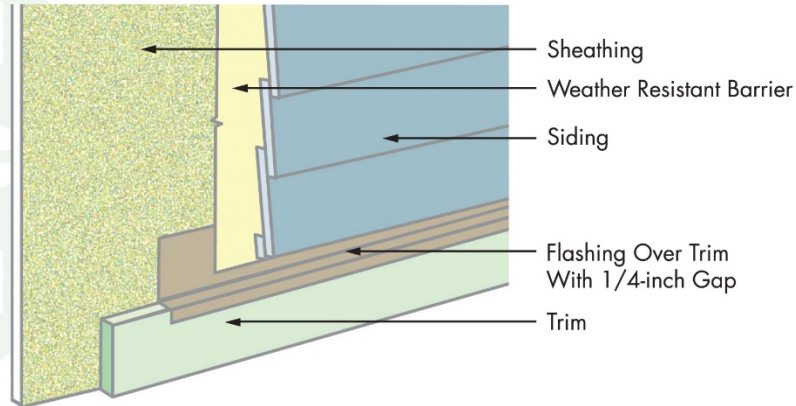
FIBER CEMENT SIDING DETAIL

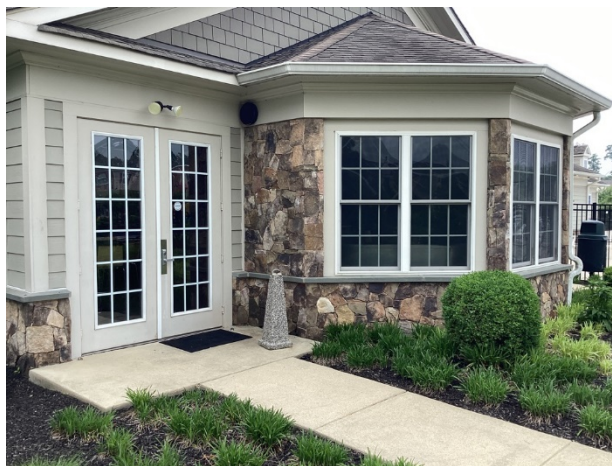
Clubhouse windows and doors

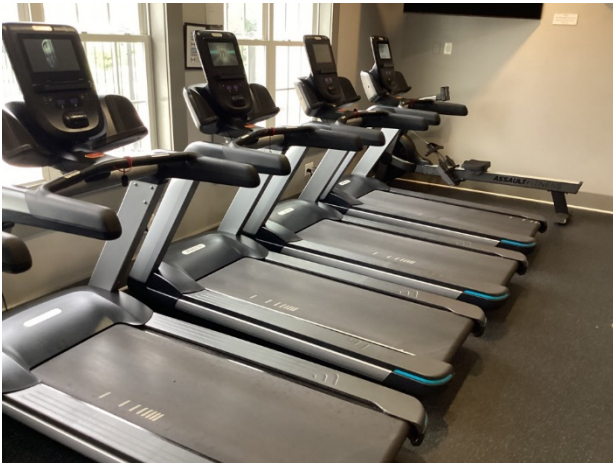
Cardiovascular equipment

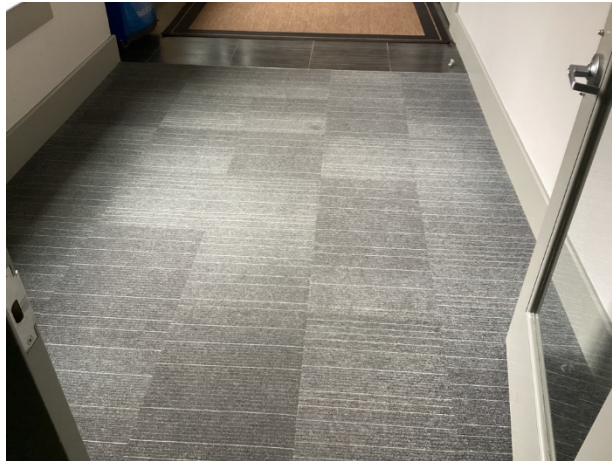
Carpet deterioration

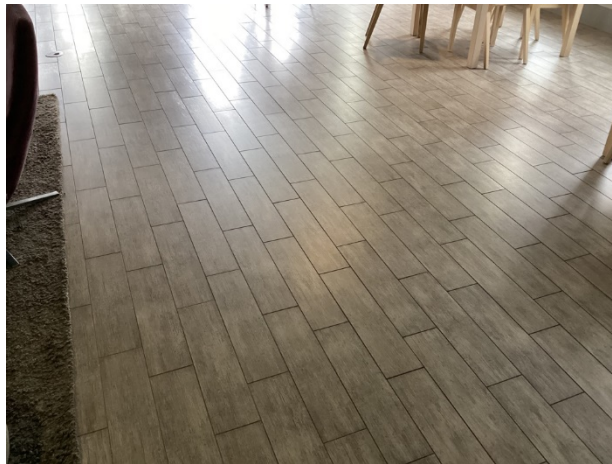
Great room tile floor covering

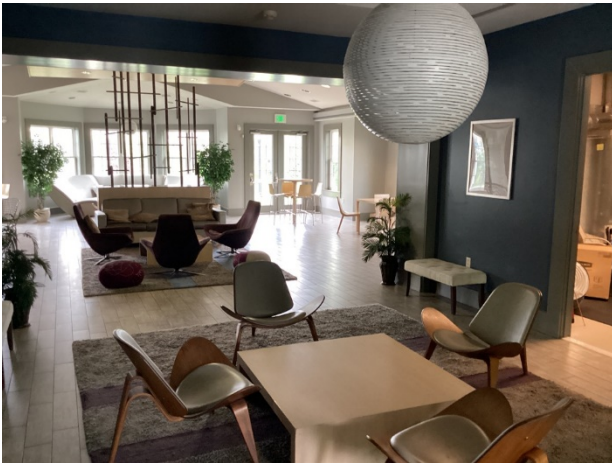
Great room furnishings

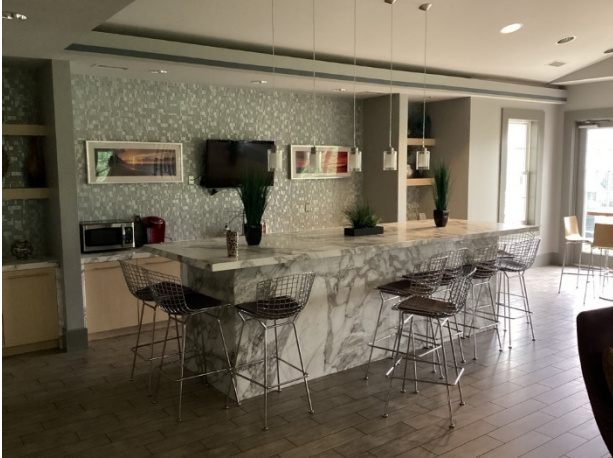
Condition: Good to fair overall with isolated countertop damage evident

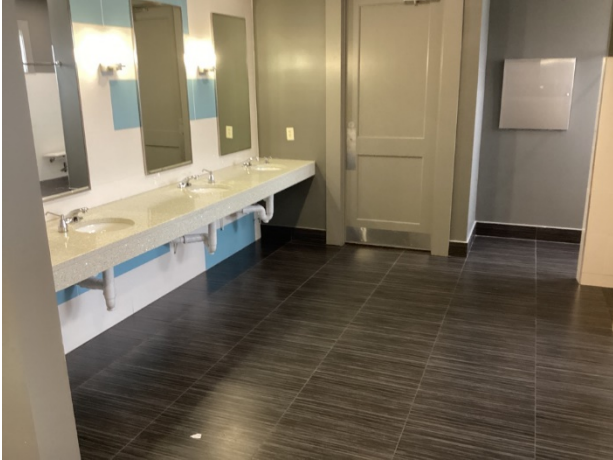
Locker room fixtures

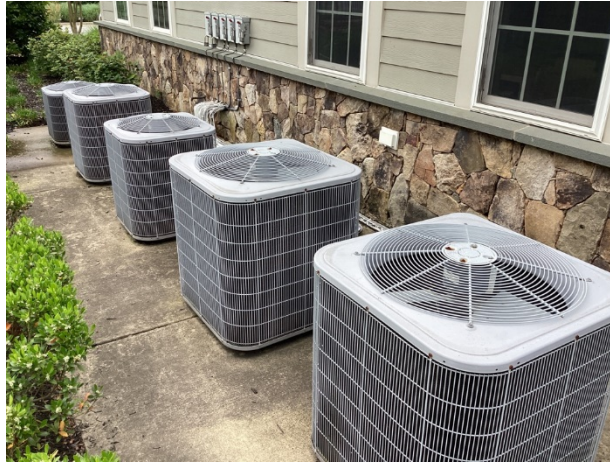
Split system condensing units

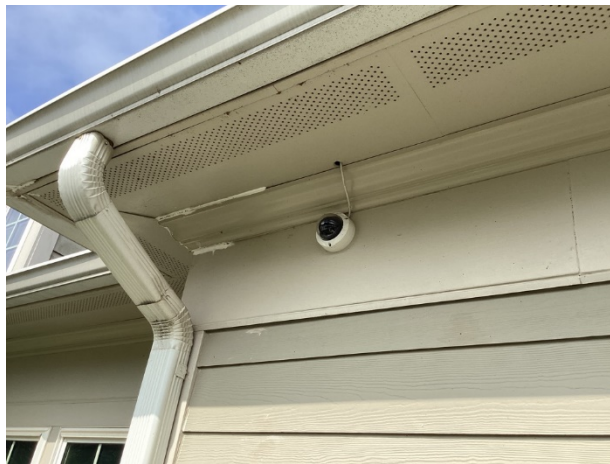
Condition: Reported satisfactory

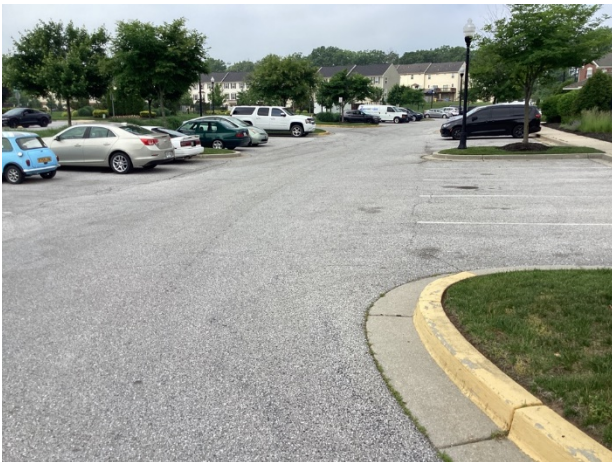
Clubhouse parking area overview
Note: Cracks.

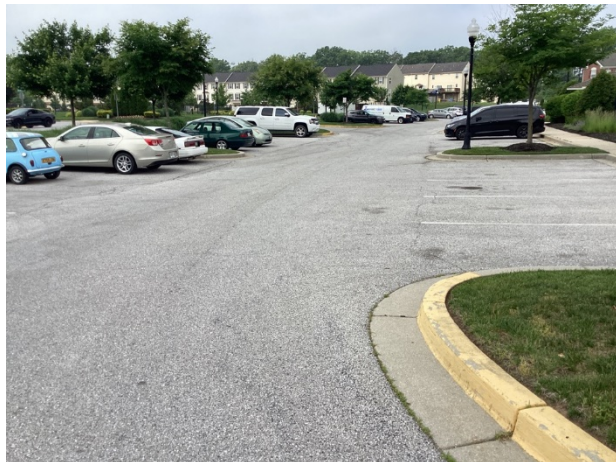
Clubhouse parking area overview
Note: Previously sealed cracks.

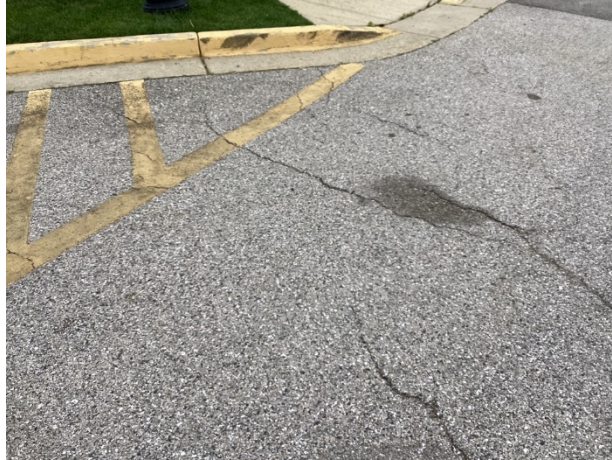
Clubhouse parking area cracks

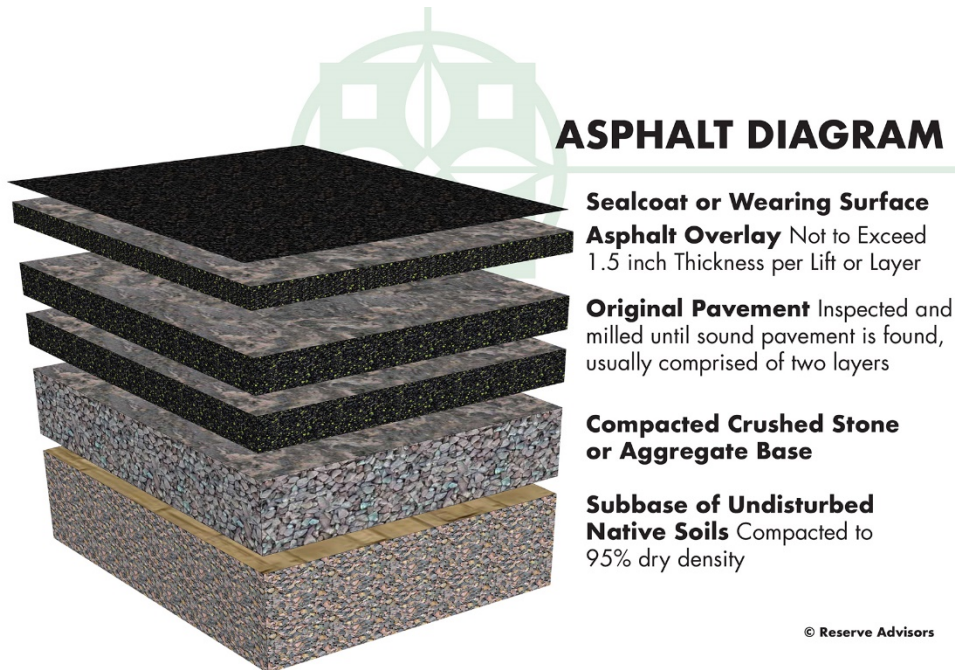
The manner of repaving is either a mill and overlay or total replacement. A mill and overlay is a method of repaving where cracked, worn and failed pavement is mechanically removed or milled until sound pavement is found. A new layer of asphalt is overlaid atop the remaining base course of pavement. Total replacement includes the removal of all existing asphalt down to the base course of aggregate and native soil followed by the

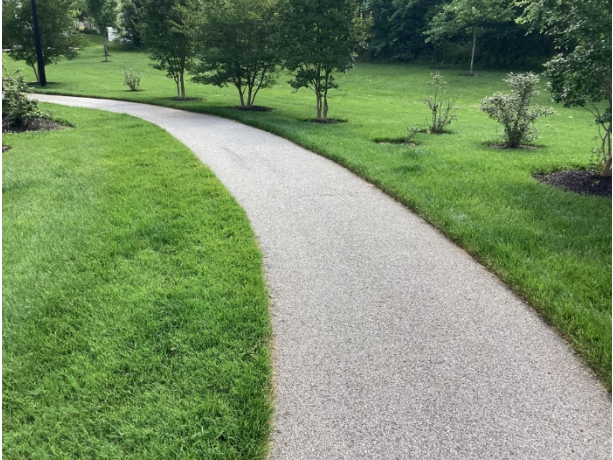
Asphalt pavement walking path overview

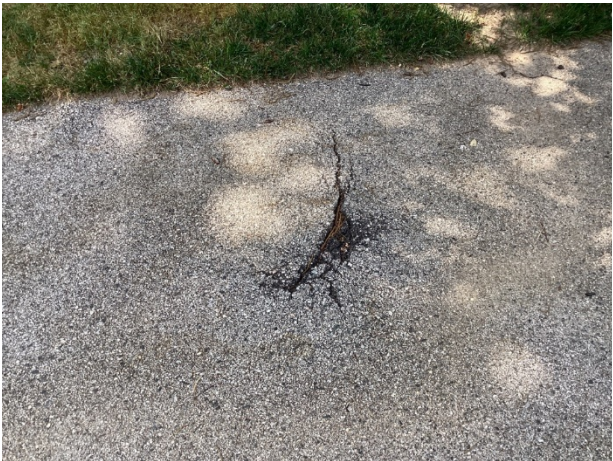
Walking path overview

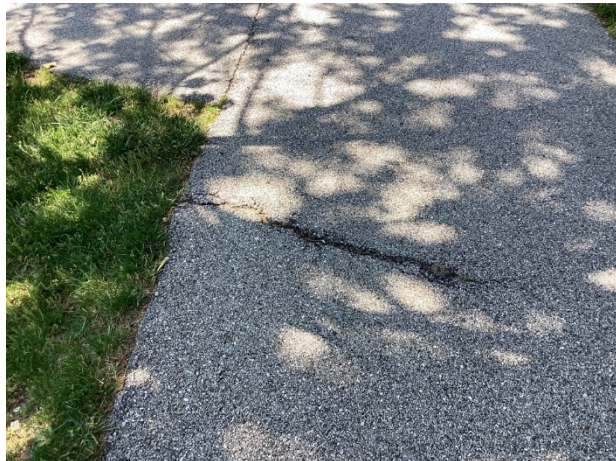
Walking path cracks and settlement

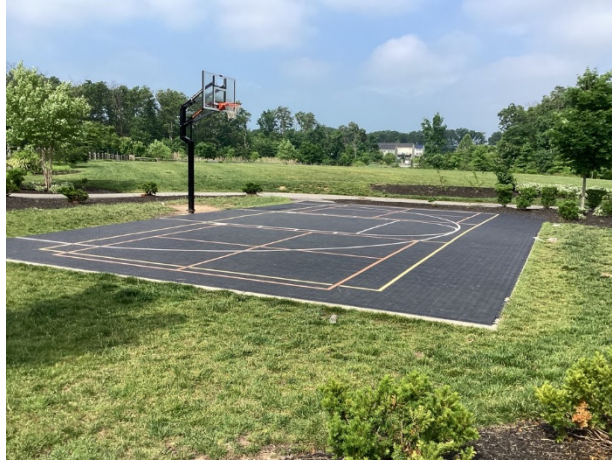
Basketball court overview

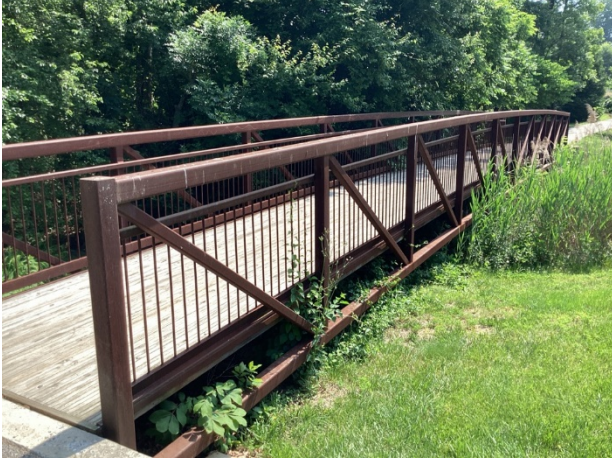
Pedestrian bridge overview

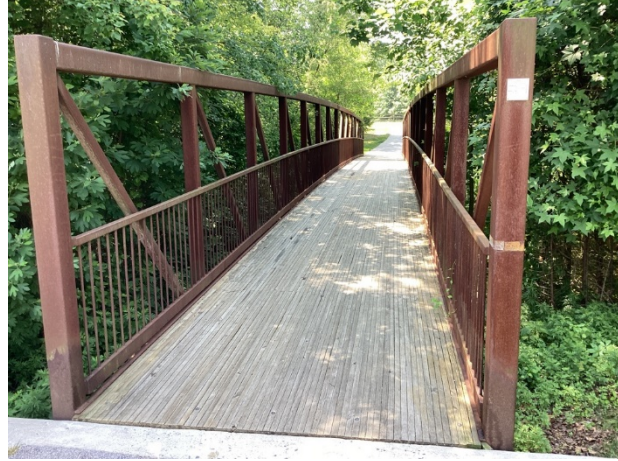
Pedestrian bridge overview

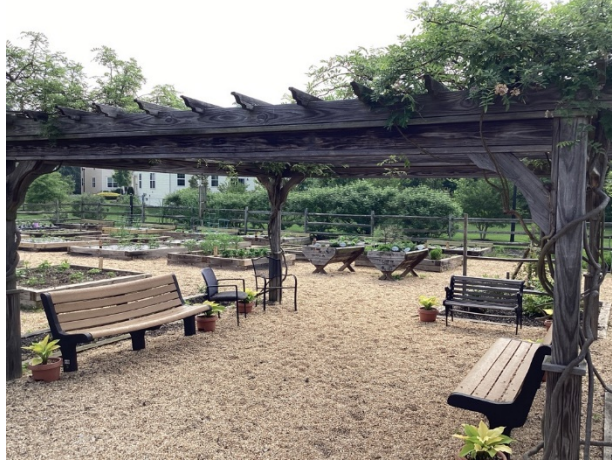
Wood pergola overview
Note: Minor wood deterioration.

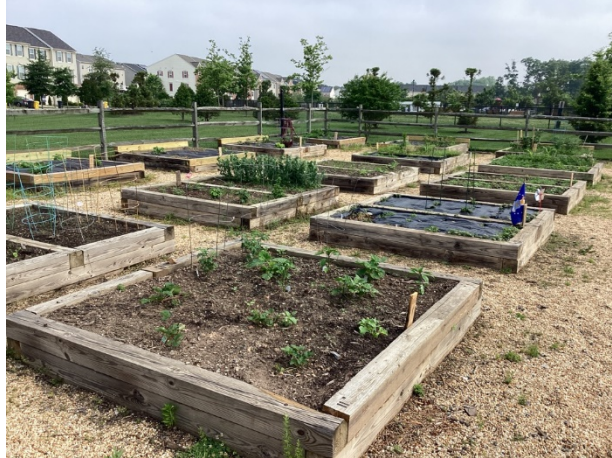
Community garden raised beds

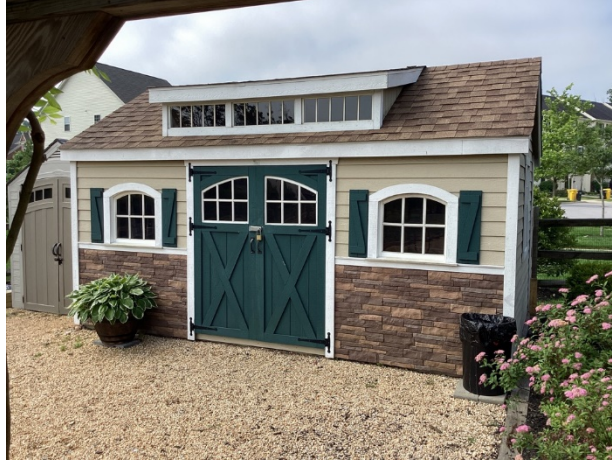
Community garden shed

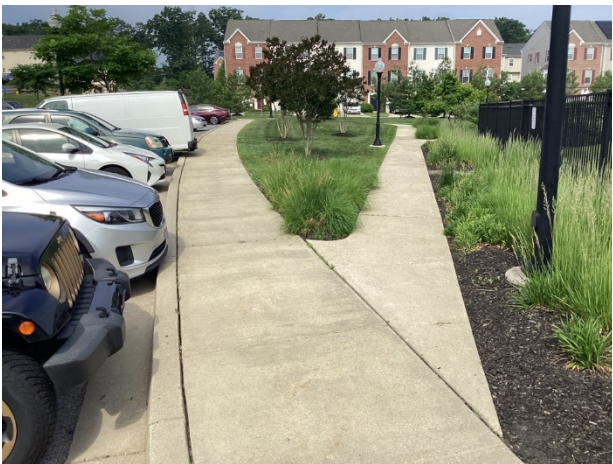
Clubhouse concrete sidewalks overview

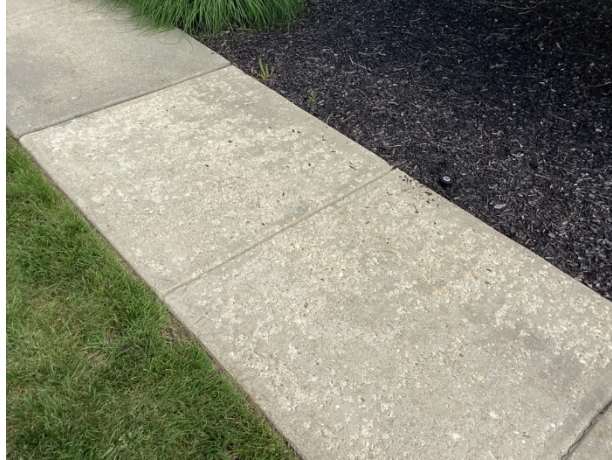
Scaling at Clubhouse sidewalk

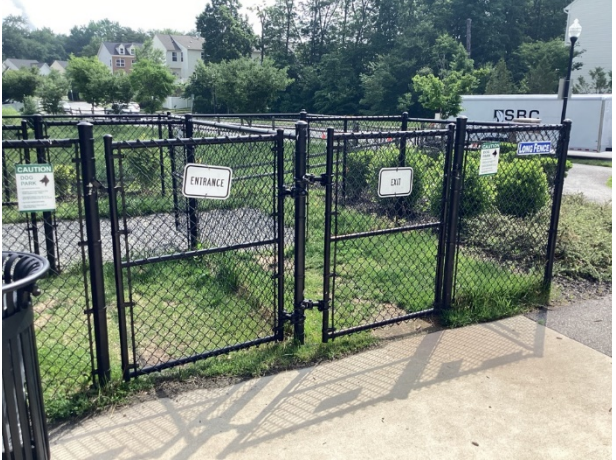
Archibald Drive dog park fences overview

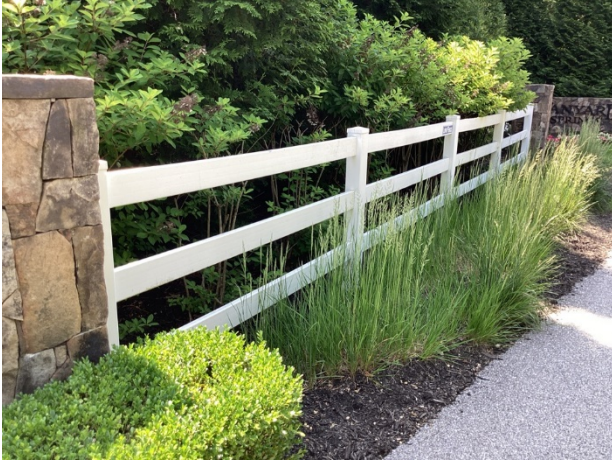
Vinyl fences at monuments

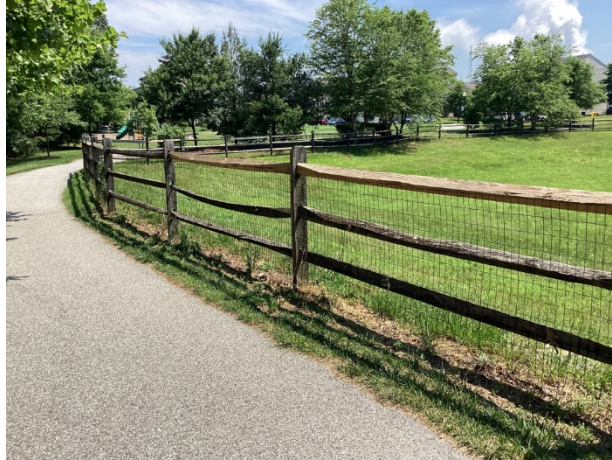
Condition: Good to fair overall with previous replacements evident

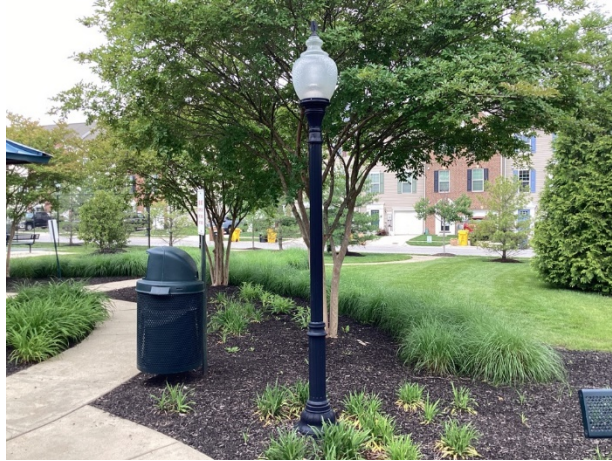
Light pole and fixture

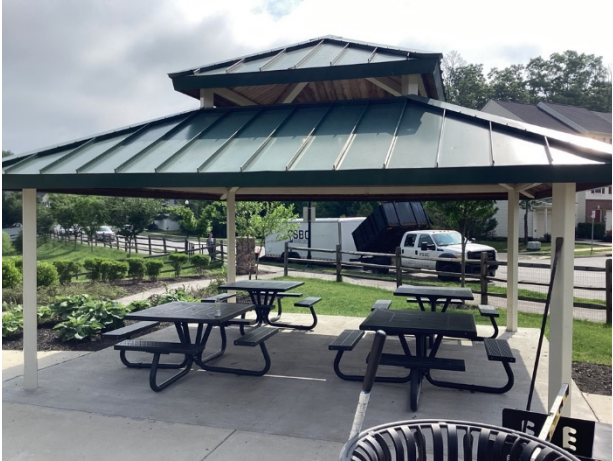
Archibald drive pavilion overview

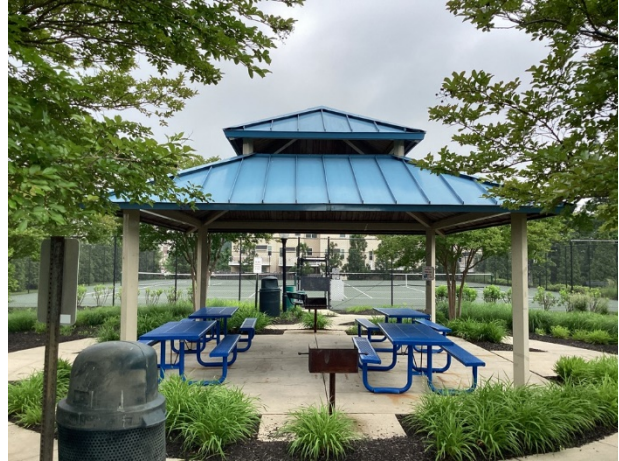
Clubhouse pavilion overview

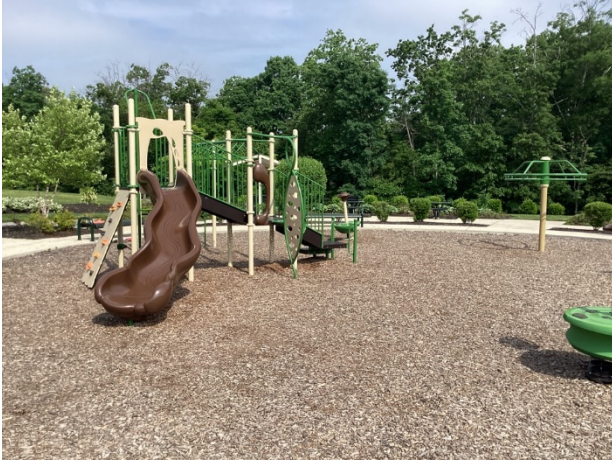
Archibald Drive playground overview

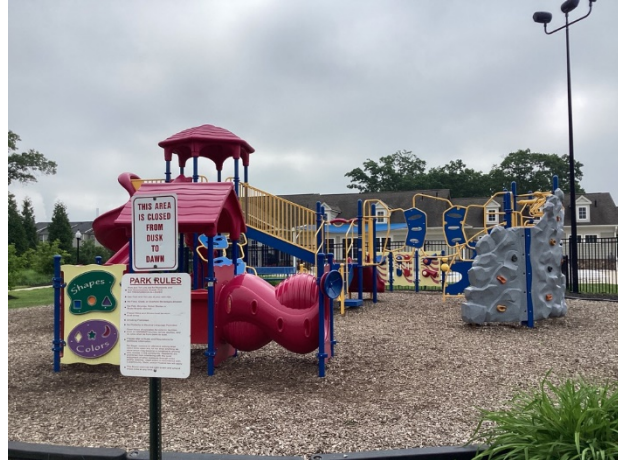
Clubhouse playground overview
Note: Minor finish deterioration.

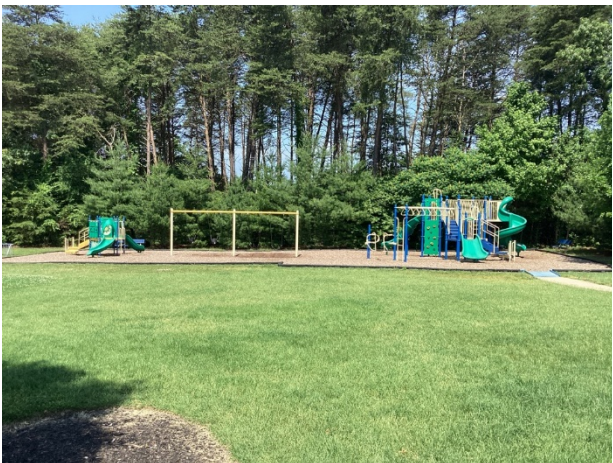
Mockingbird Circle playground overview
Note: Finish deterioration.

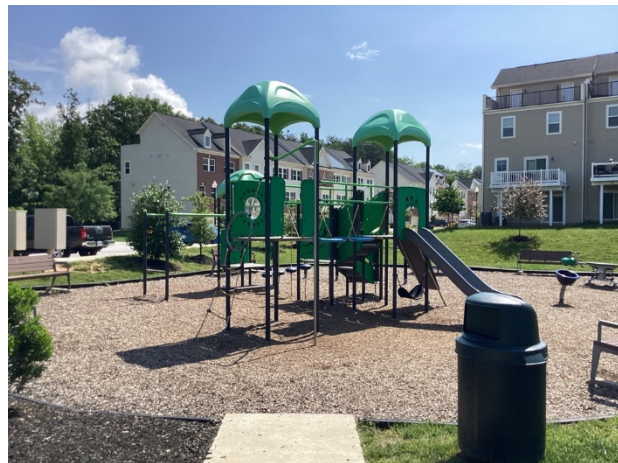
Tanyard Knoll Lane playground overview

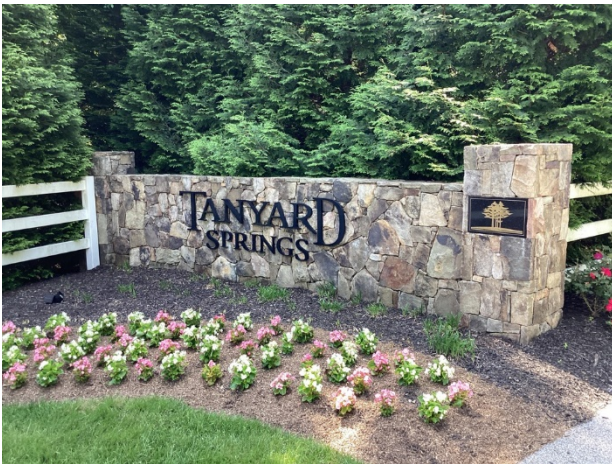
Property identification entrance monument and landscaping

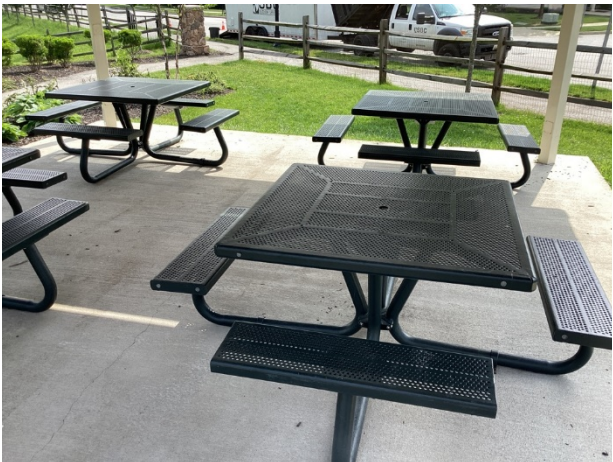
Condition: Good to fair overall with rust evident

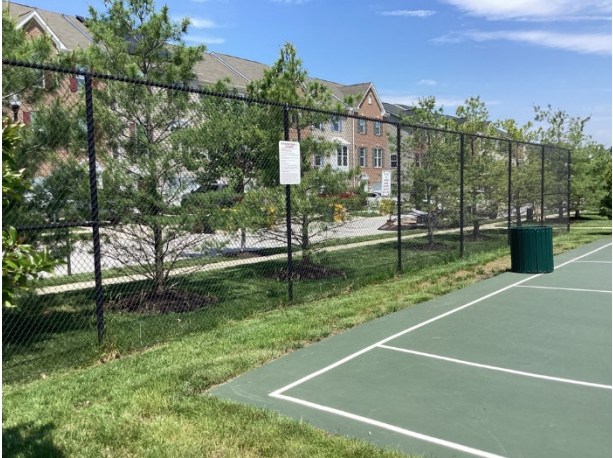
Basketball court fence overview

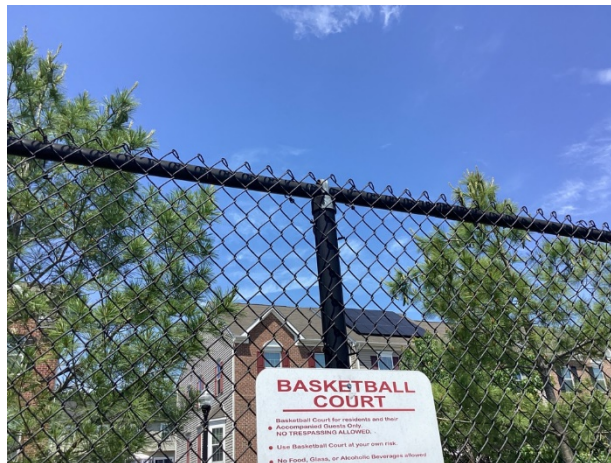
Finish deterioration at top of fence

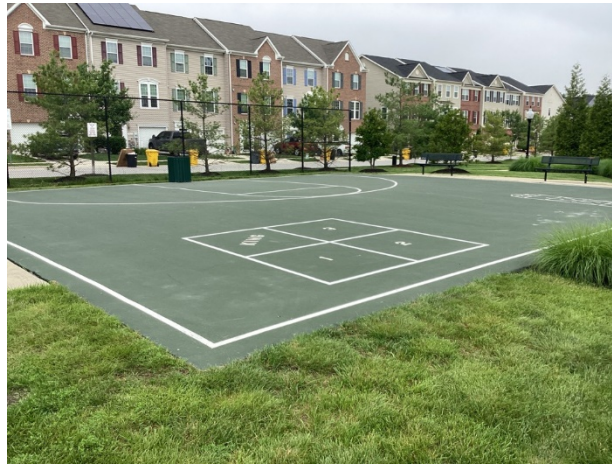
Basketball court surface overview

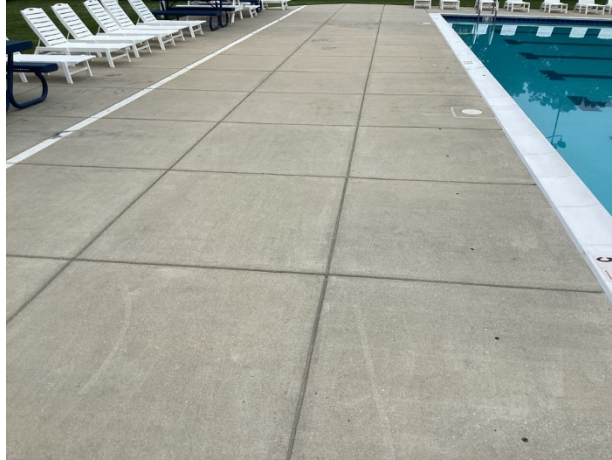
Concrete deck overview

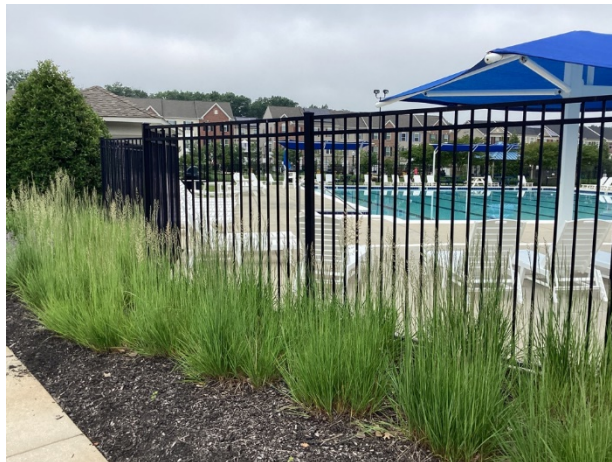
Aluminum fence overview

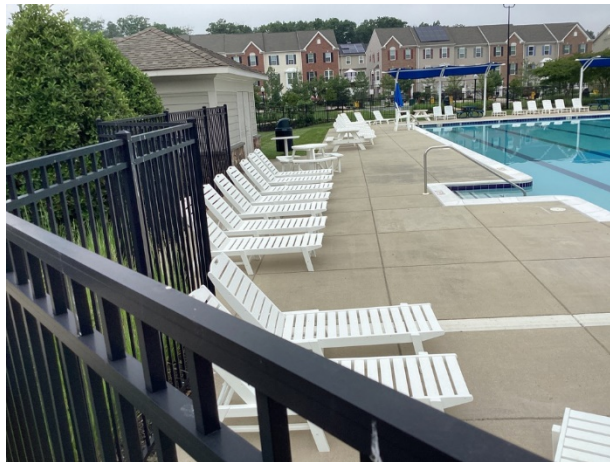
Condition: Good overall

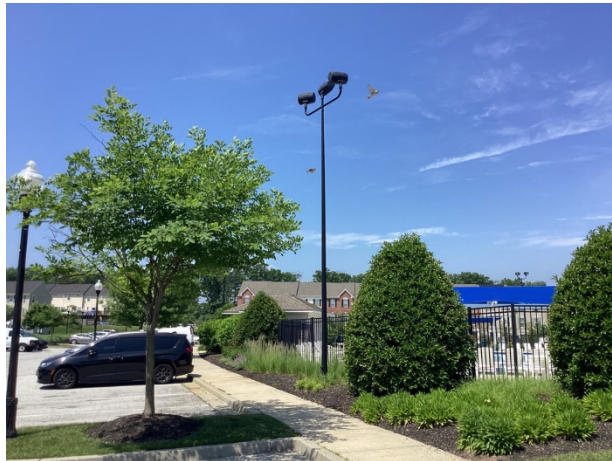
Light pole and fixtures

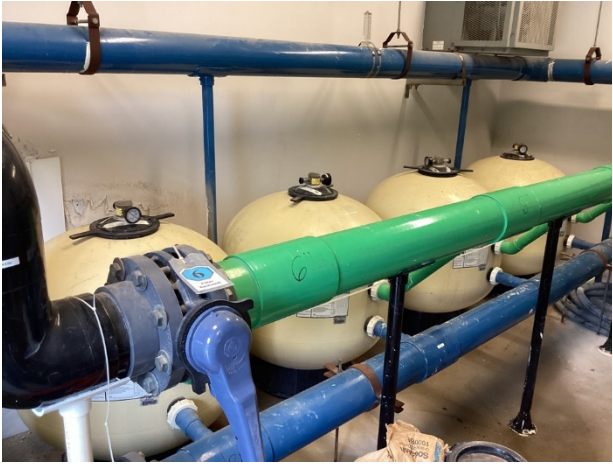
Pool filters and valves

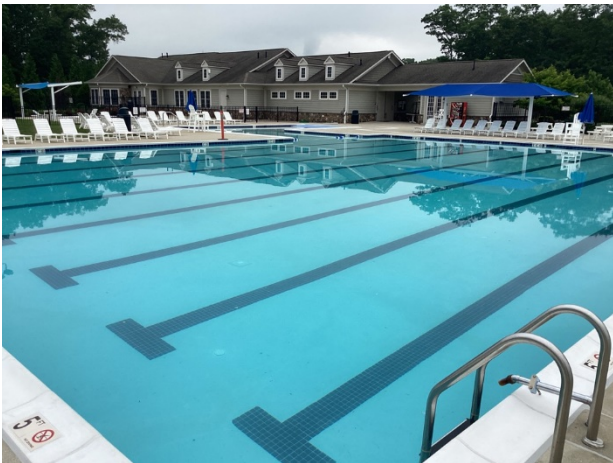
Condition: Good overall

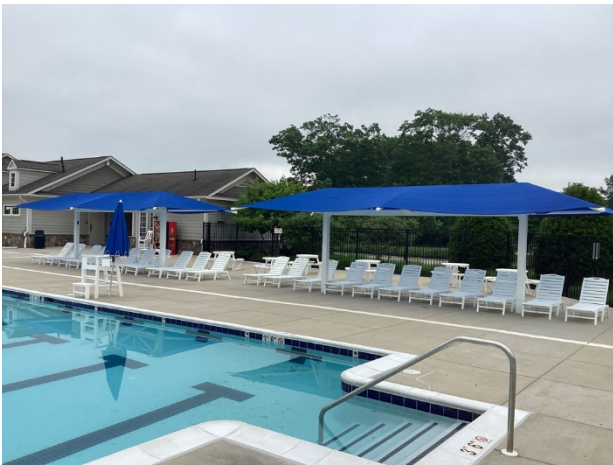
Condition: Good to fair overall with fastener rust evident

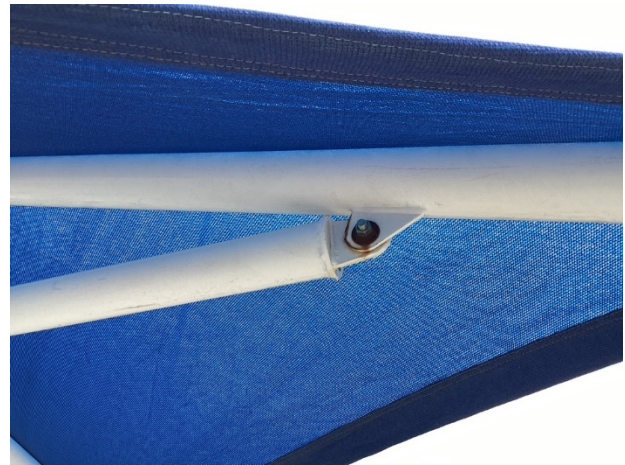
Fastener rust at connection

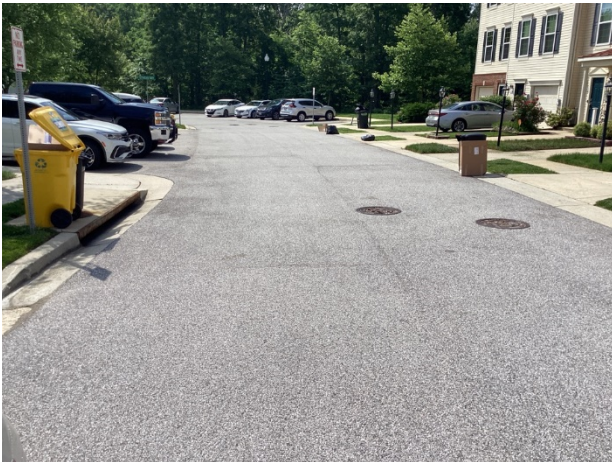
Section A pavement overview

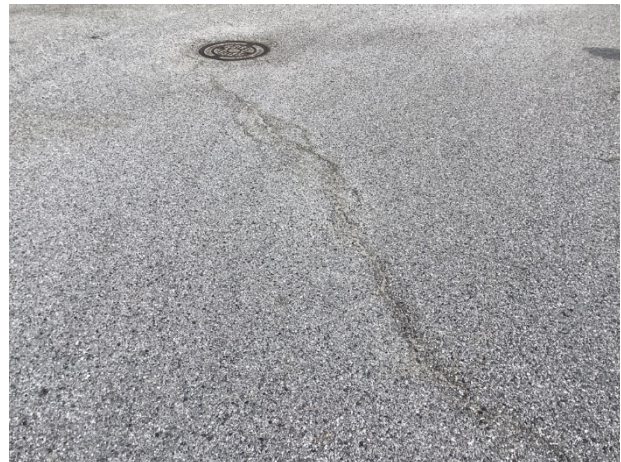
Section B and C pavement cracks

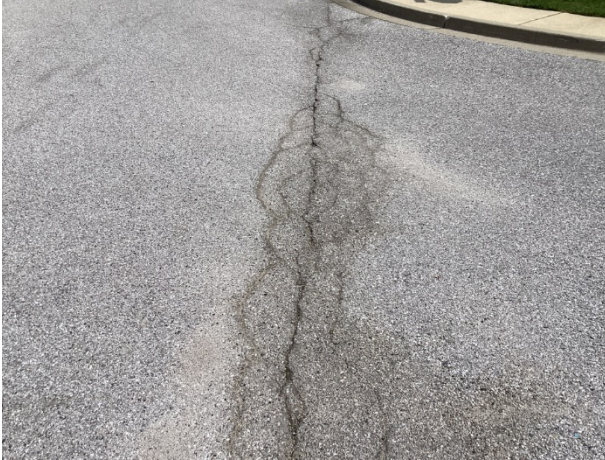
Section B and C pavement cracks

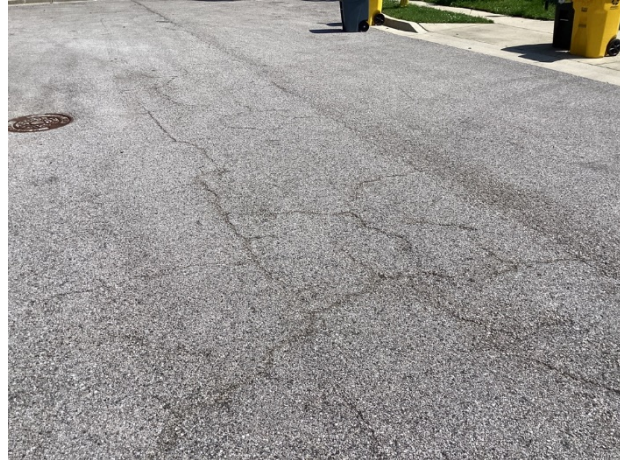
Section B and C pavement cracks

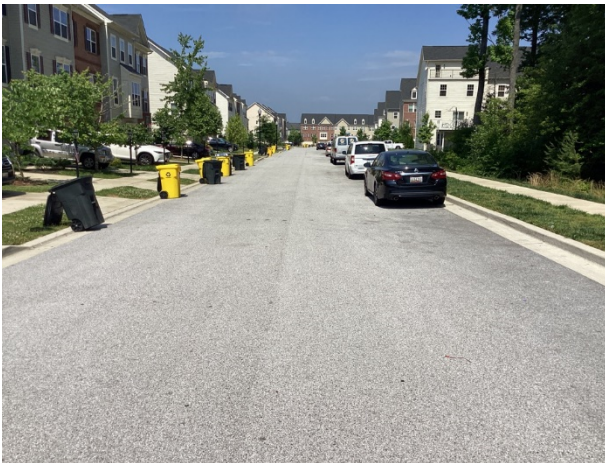
Section D and Oak Pointe pavement overview

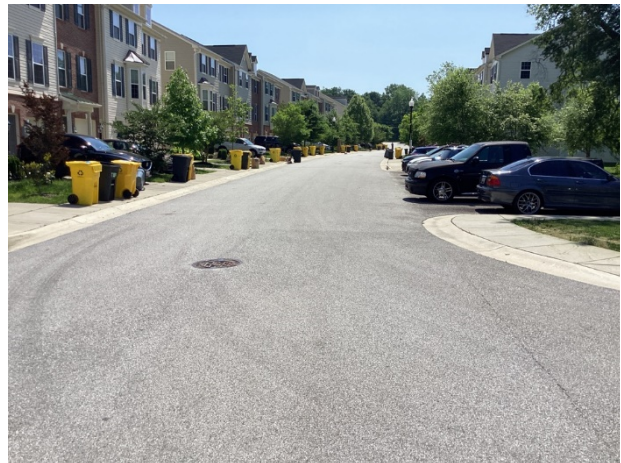
Section D and Oak Pointe pavement overview

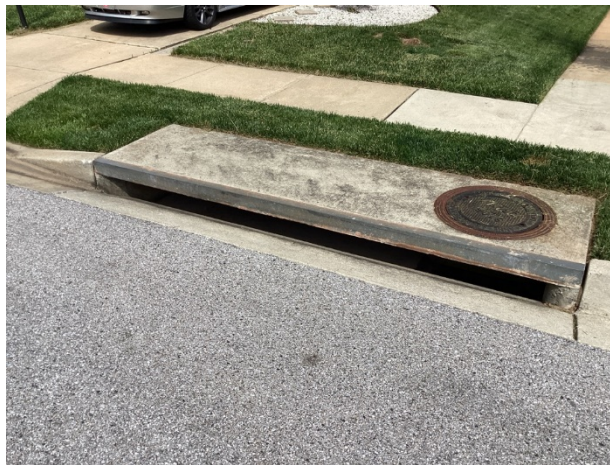
Typical townhome street and parking area catch basin

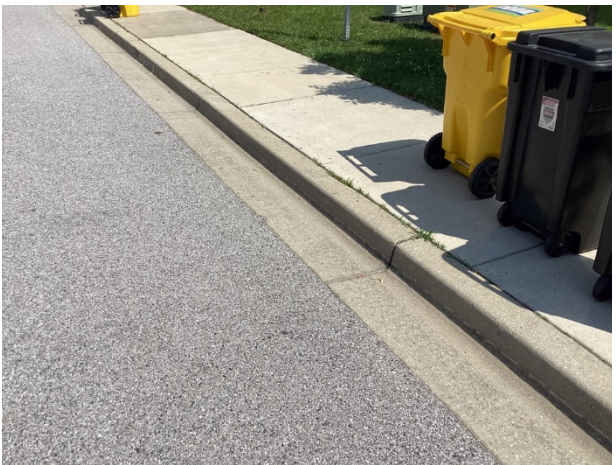
Concrete curb and gutter overview

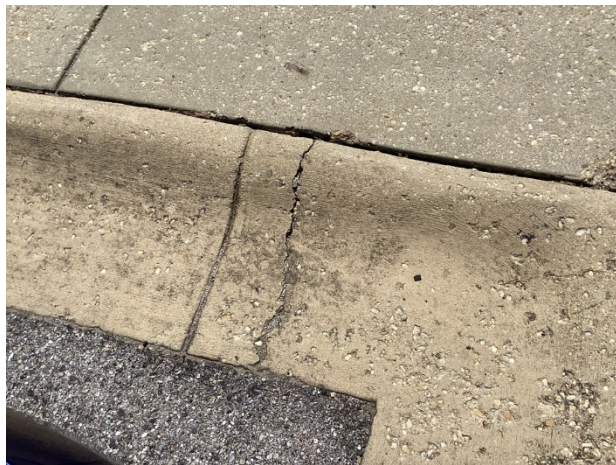
Curb and gutter cracks

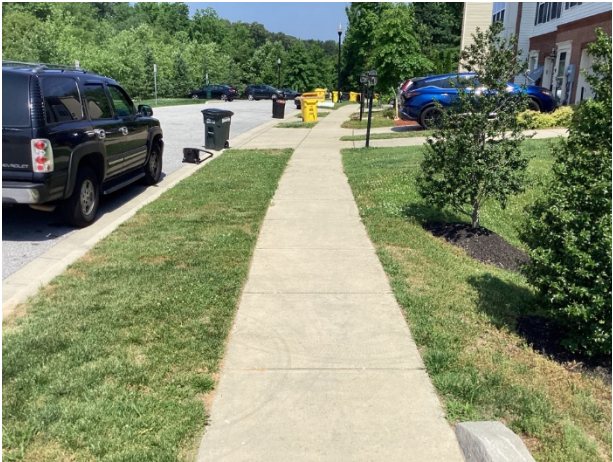
Concrete sidewalk overview

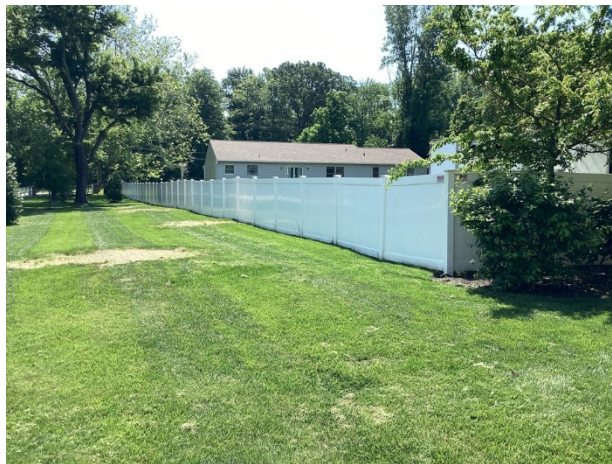
Vinyl fence overview

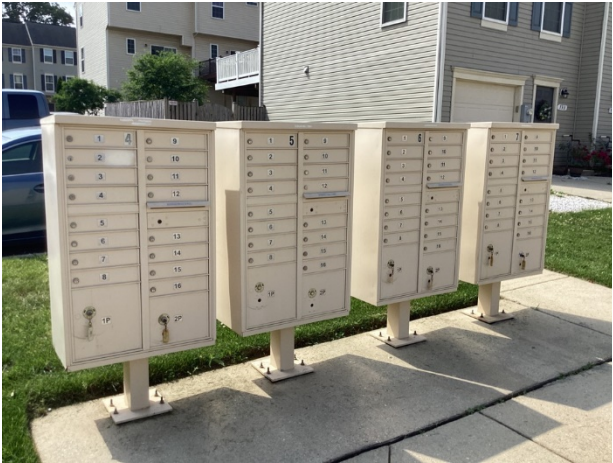
Typical mailbox stations

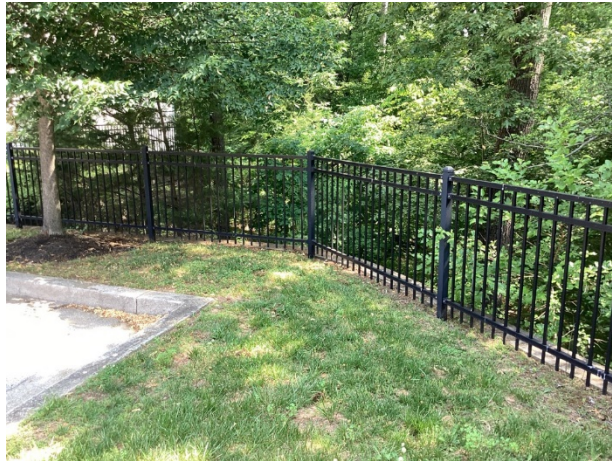
Aluminum railing overview
Note: Finish deterioration.

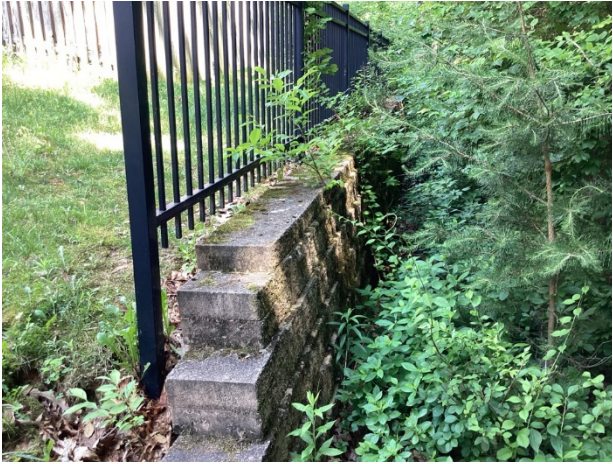
Retaining wall overview

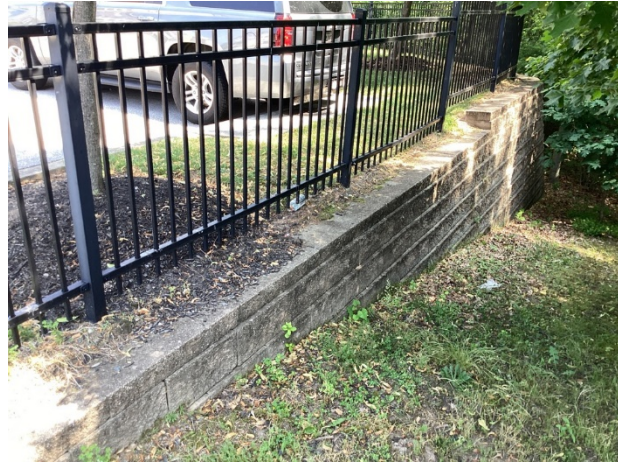
Retaining wall overview

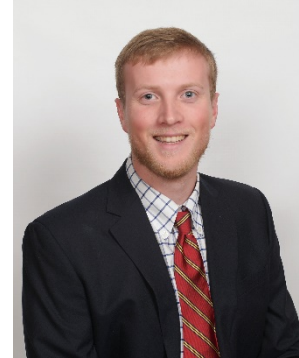
The following is a partial list of clients served by Matthew Casey demonstrating his breadth of experiential knowledge of community associations in construction and related buildings systems.
